Shingle extraction and bird breeding on the Ashley-Rakahuri river
Case study – Taggart Earthmoving Ltd operation at end of Swamp Road
September-December, 2018

Nick Ledgard and Grant Davey, Ashley-Rakahuri Rivercare Group

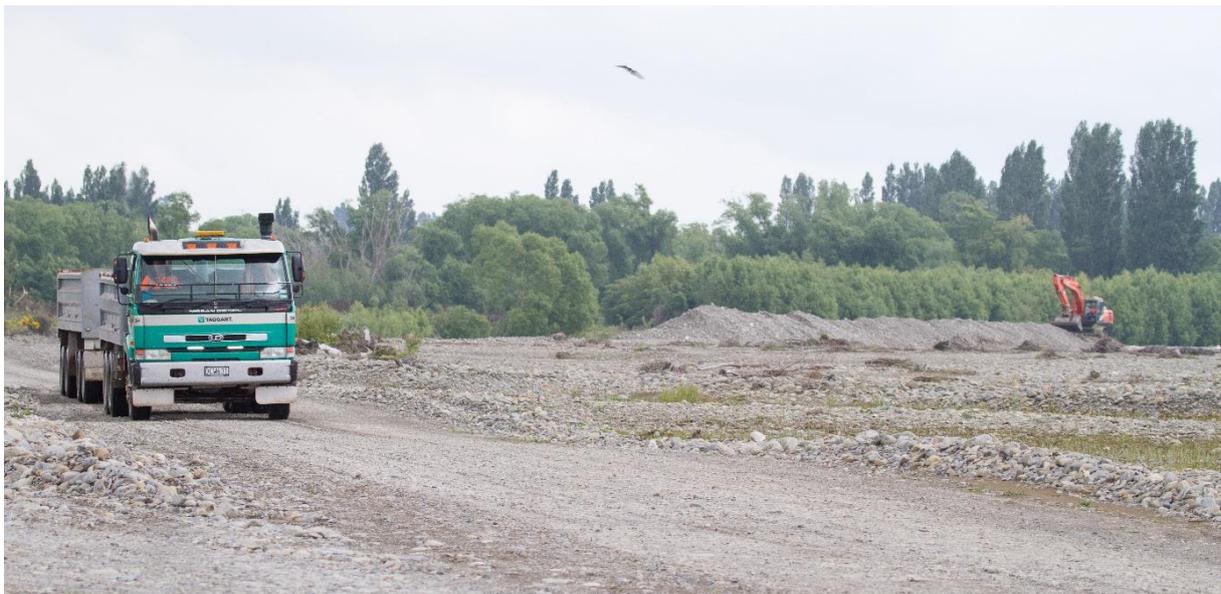
A Taggart Earthmoving Ltd truck and working digger in the Swamp Road extraction site close to where banded dotterels and black-fronted terns were nesting.

- Similarly with the digger extracting and mounding shingle. Generally the operational area of this machine is very restricted.
- Movement by employees away from machinery should be discouraged. Birds will happily occupy nests in close proximity to machines, but are disturbed when operators leave machines and wander around. TEL operators were encouraged not to do this e.g. to have lunch sitting inside machines or trucks.

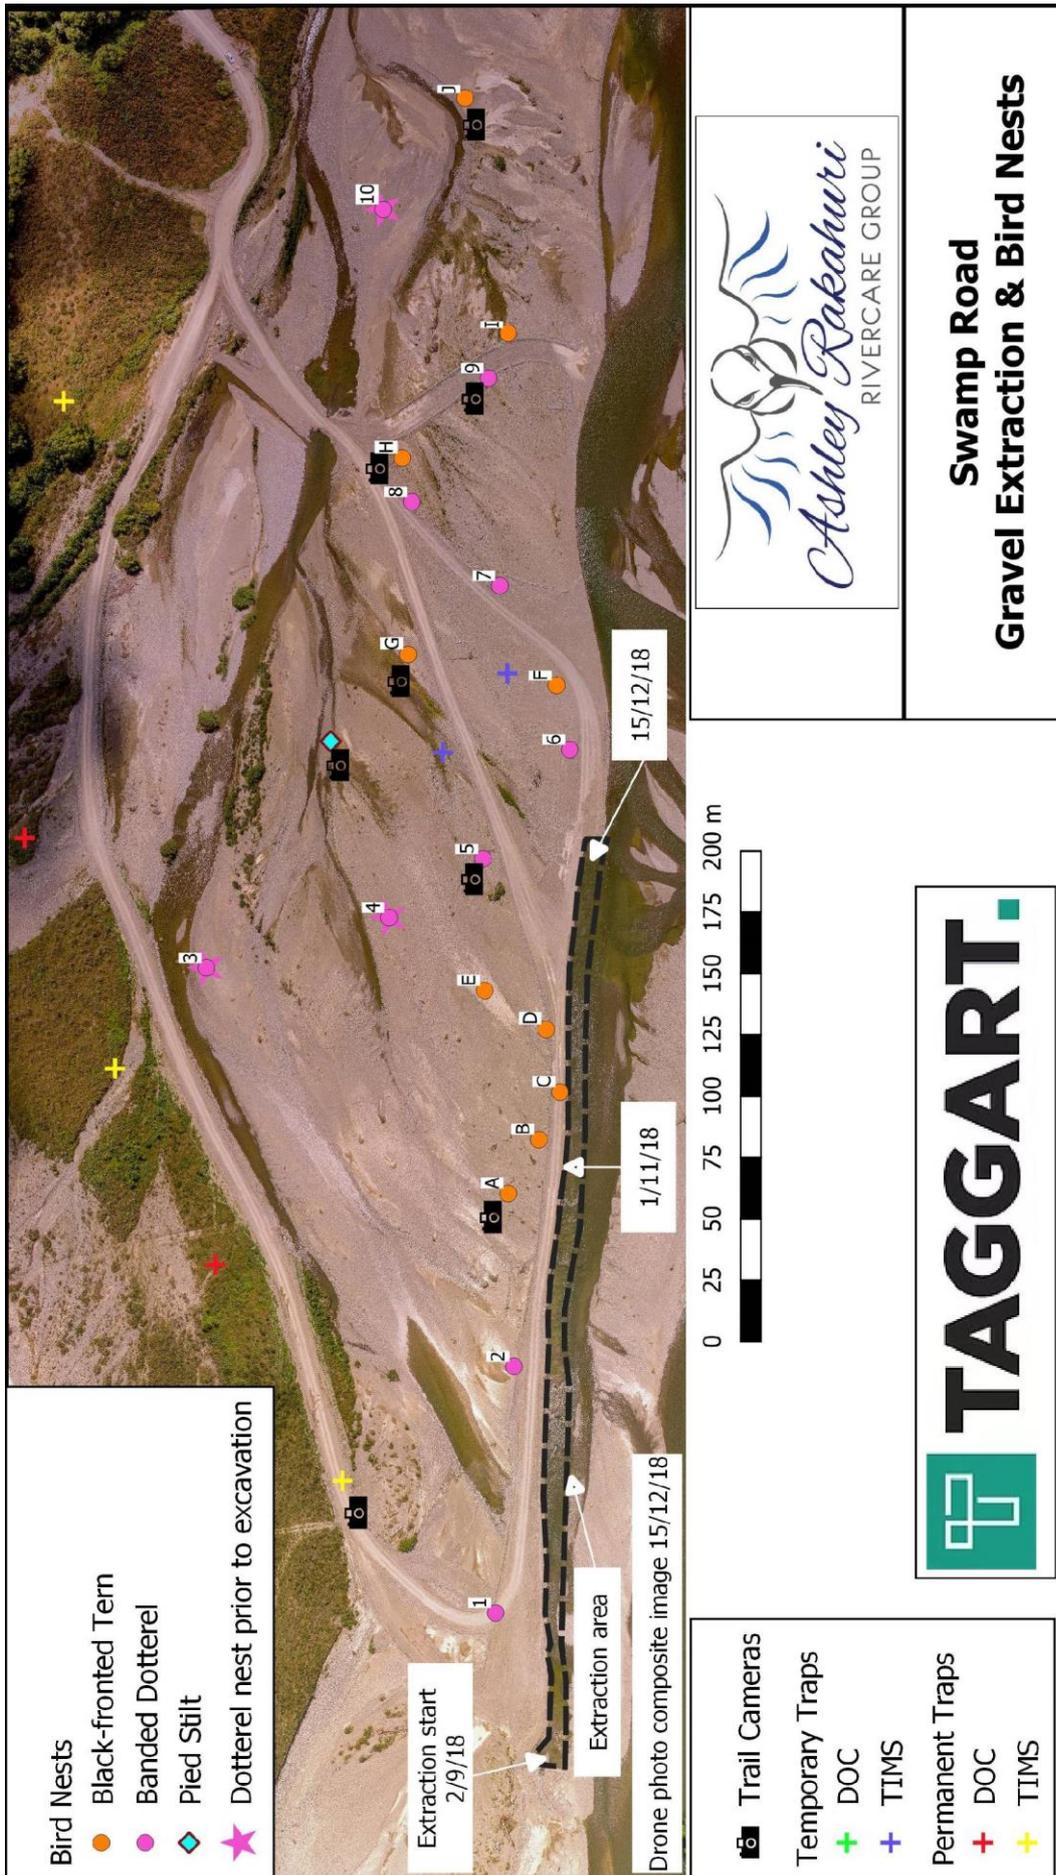
Map 1. Gravel extraction activities and bird nests

The site in question is at the end of Swamp Road, about 3km below the Okuku river junction (Map 1). This map was composited from 54 drone photos taken from 100m height and georeferenced in QGIS. Note that this image was taken after a flood and after most of the nesting activity had finished, thus the extent of the extraction area was greater than when the birds were nesting. The access tracks remained almost the same.

On the September 18 pre-operation bird survey, the species recorded by AC in the entire proposed extraction area were 15 black-fronted terns (BFT), 10 BDs, 2 pied stilts (PSs) and 1 South Island Pied Oystercatcher (SIPO). A week later, seven BD nests had been located, which included four new ones with 3 eggs each and three found earlier but where the eggs had disappeared – for reasons unknown, although predation was subsequently suspected. There was also a PS nest with 4 eggs. A list of nests is presented in Table 1 with locations shown on Map 1.

All distances were taken from the GIS Map (1) and are presented in Table 1. Many nests of both BD and BFT were in close proximity to the shingle extraction zone and access tracks. All these, except three (8, 10 and 11 - see Map 1) were established while the site was being actively worked. Observations were that both BD and BFT would sit tight on nests with trucks passing close by, although those closest (within 5m) would sometimes leave the nest for a minute or two while a truck drove past. Three BD nests (2, 5 and 7) within 15m of an access track were seen to hatch chicks, although the track closest to nest 7 (<5m away) was not frequently used by trucks. Six BFT nests (B, C, D, F, H and I) were within 10m of tracks, most of them by the main track used multiple times daily. All of these nests failed to hatch eggs, but the cause is strongly suspected to be predation, as shell fragments were found (see Predation section below). Apart from nest C, where a single egg was laid actually on a track over a weekend, only one nest (G) was abandoned / deserted i.e. eggs still in nest with adults absent. One pair (A), nesting only 25m from a track and the main shingle digging and truck loading site, were seen to hatch and feed chicks, but it is not known if the chicks fledged. Another BFT pair (G) nested 15m away from the main track, but abandoned the nest (eggs still intact) after 12 days. At this time it was the only one of the original BFT pairs still present within the extraction site. The single PS pair which nested in the extraction area was over 100m away from any access track. This pair hatched four chicks, two of which reached the fledging stage.

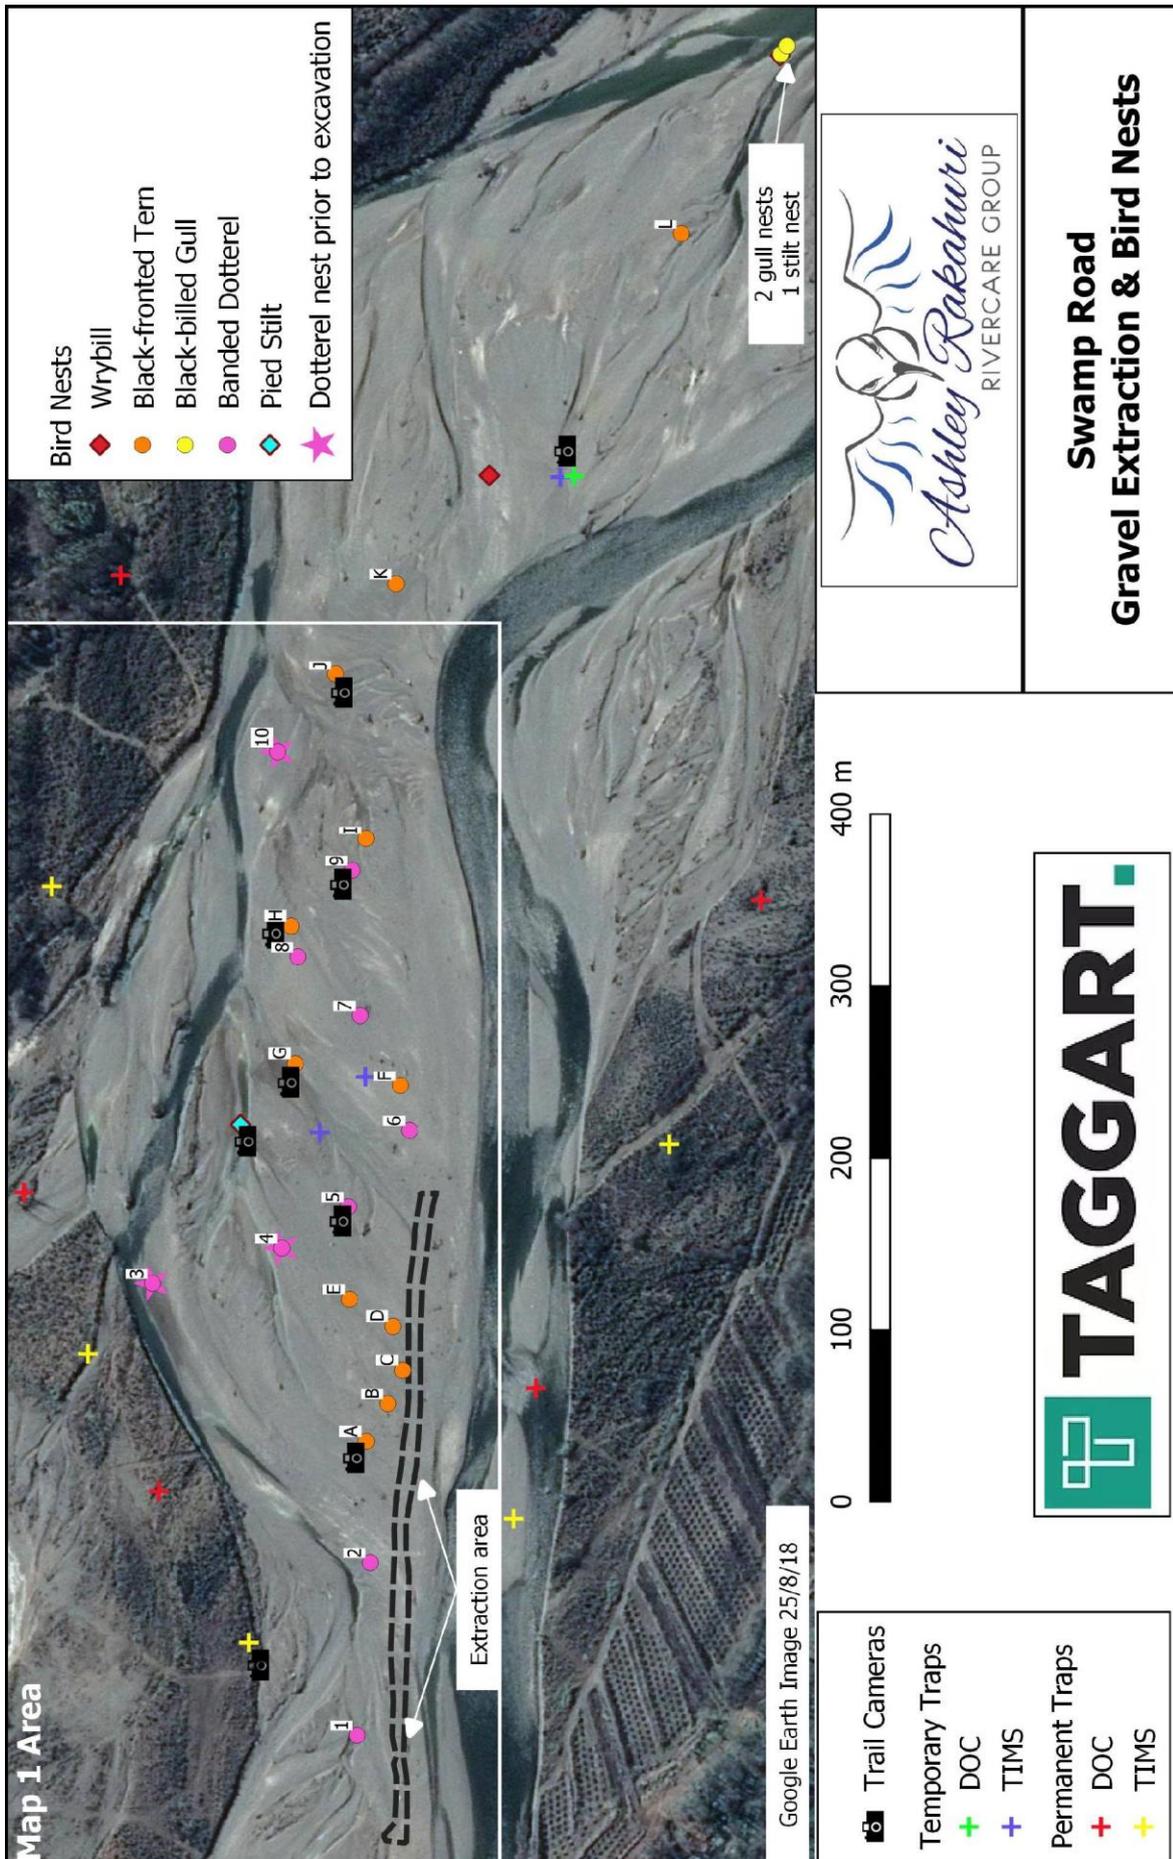
Map 2. Gravel extraction activities and bird nests – wider area

BD nests averaged 67m apart, with the closest being 45m. Five BFT nests were in a tight cluster near the digger extraction site, where they were 22 – 29m apart, averaging 26m. The seven BFT nests further east, including two outside the extraction area (Map 2) were 62 – 97m apart, averaging 74m.

The major lesson from this case study is that shingle extraction and shorebird breeding can co-exist in close proximity. There was even evidence that birds may be attracted to a shingle extraction site, as many more BD and BFT nests were found within the operation area than outside it – see Map 2.
