## Note on Ashley River Overhead Line Bird Kill

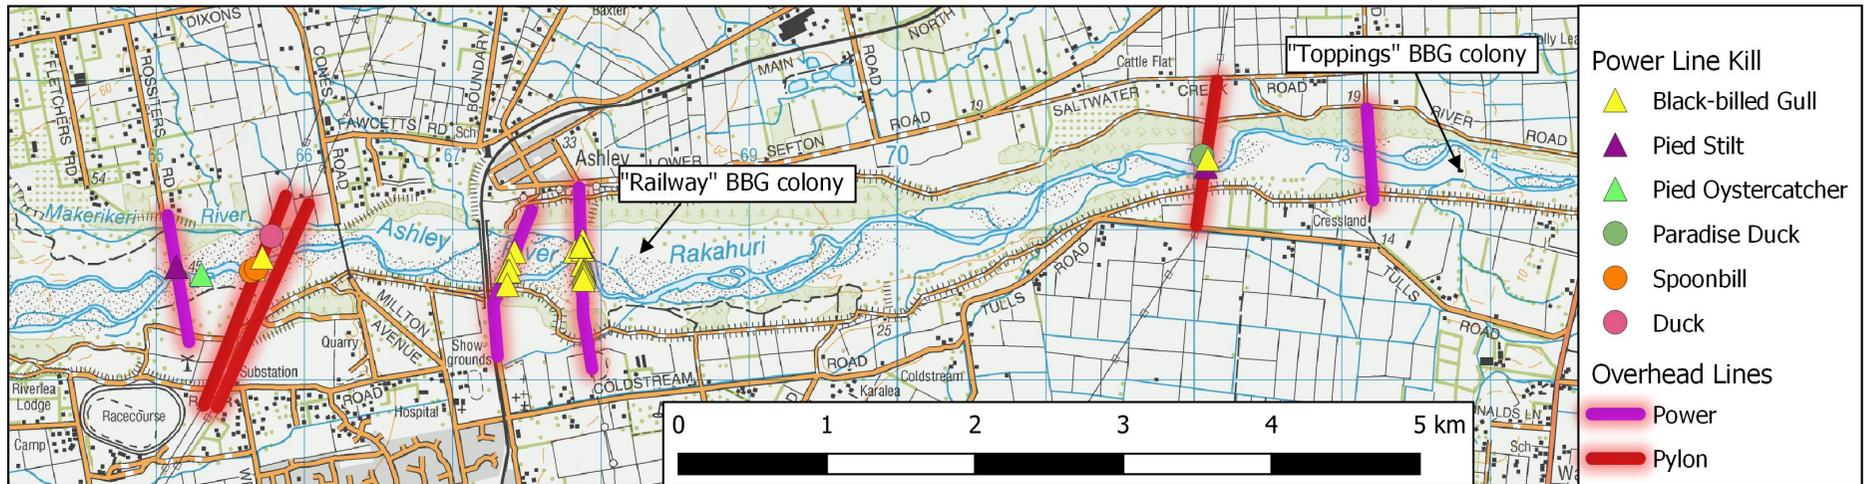
*Overhead lines and birds killed*

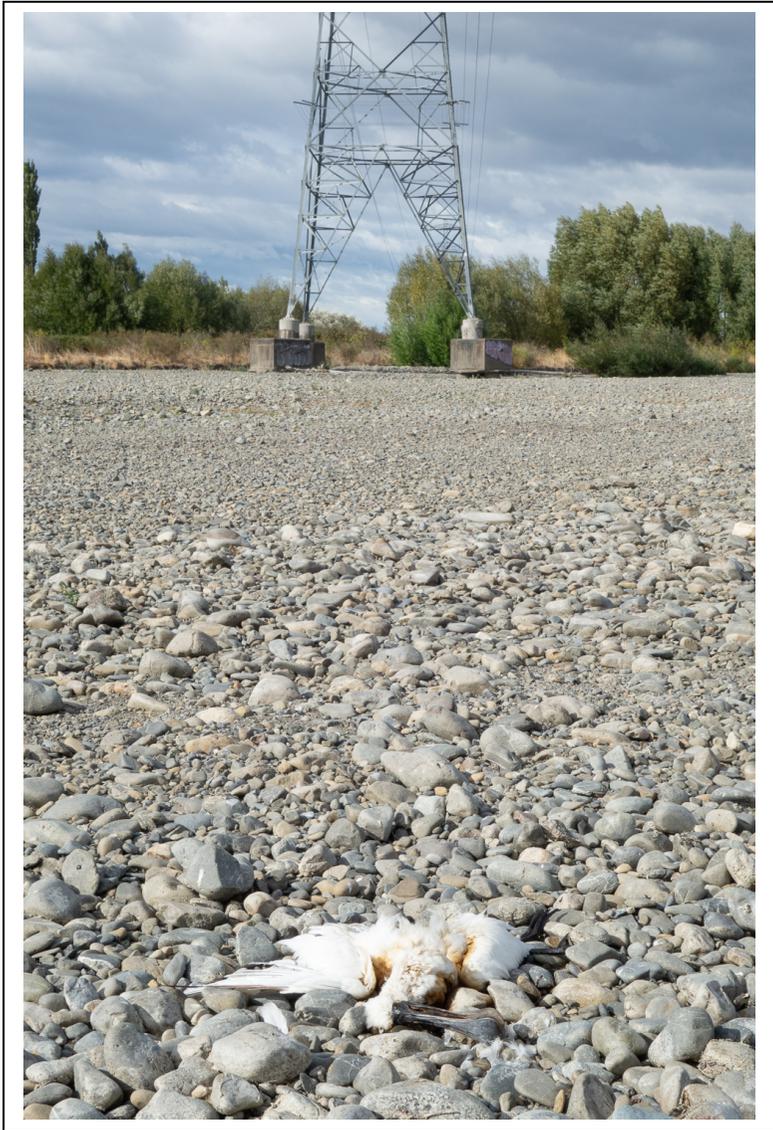
Perhaps the most disturbing aspect of the overhead line bird kill is the 2 spoonbill found under the westernmost pylon lines. Spoonbill are normally a very rare sight along the Ashley – but there often

*Dead spoonbill beneath pylon lines*

- It is perhaps possible for the power companies to make the lines more visible; this could be explored when we have more information.

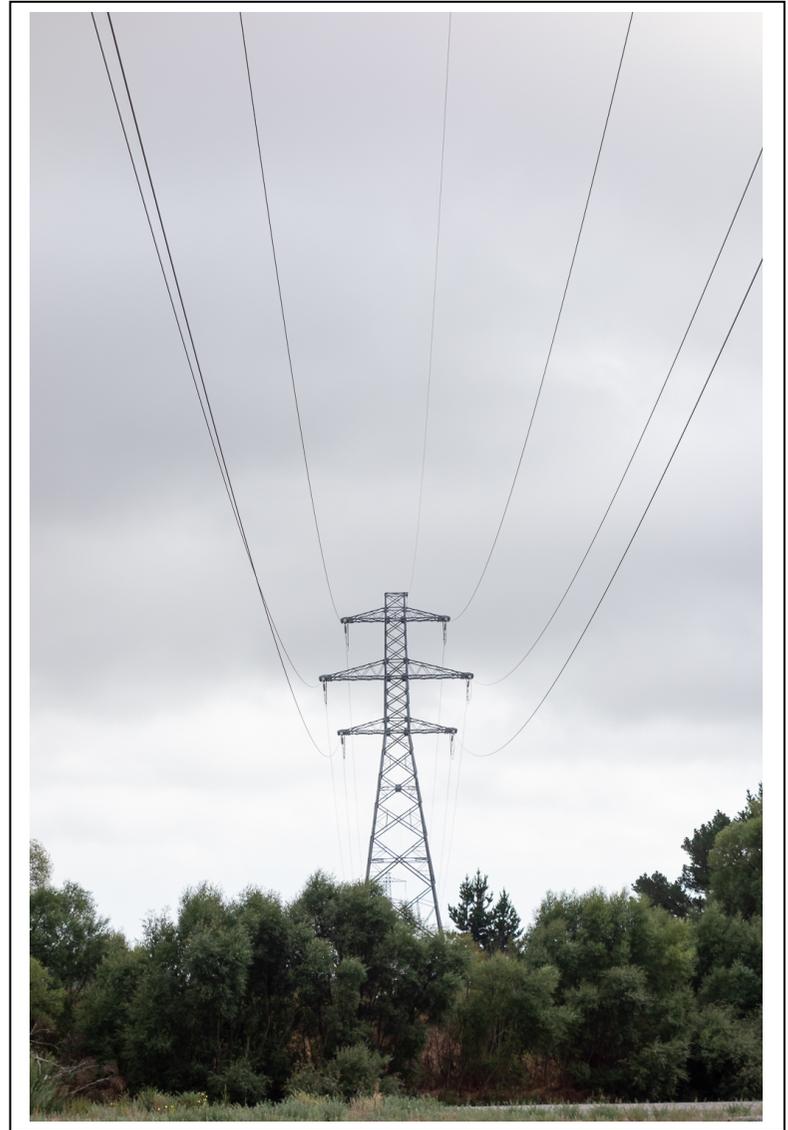
seems to be a resident population of around a dozen at the estuary. Nine of these were seen along the upper part of the river on 31 January. They appear to have come up the river to take advantage of easy prey in the shallowing water. The westernmost pylons have a thin wire running along the top – this is much less visible than the transmission wires.

*Same pylons - note thin high wire at top*
