Aspects of the Ashley River Weed Problem

1. Introduction

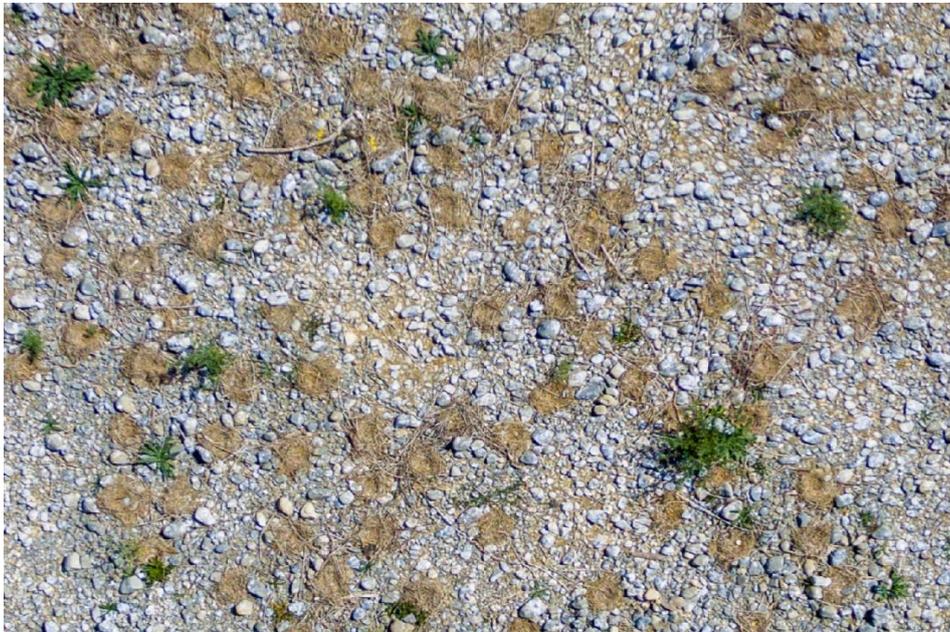
Figure 10 shows a similar relationship between gravel character and nest position as with BFT and Figure 11 documents the maximum pebble size within 25cm of the nests. The photomosaics were georeferenced, so pebble size could be measured directly within QGIS.

Figure 10. Part of Toppings 2019 - 2020 BBG colony area

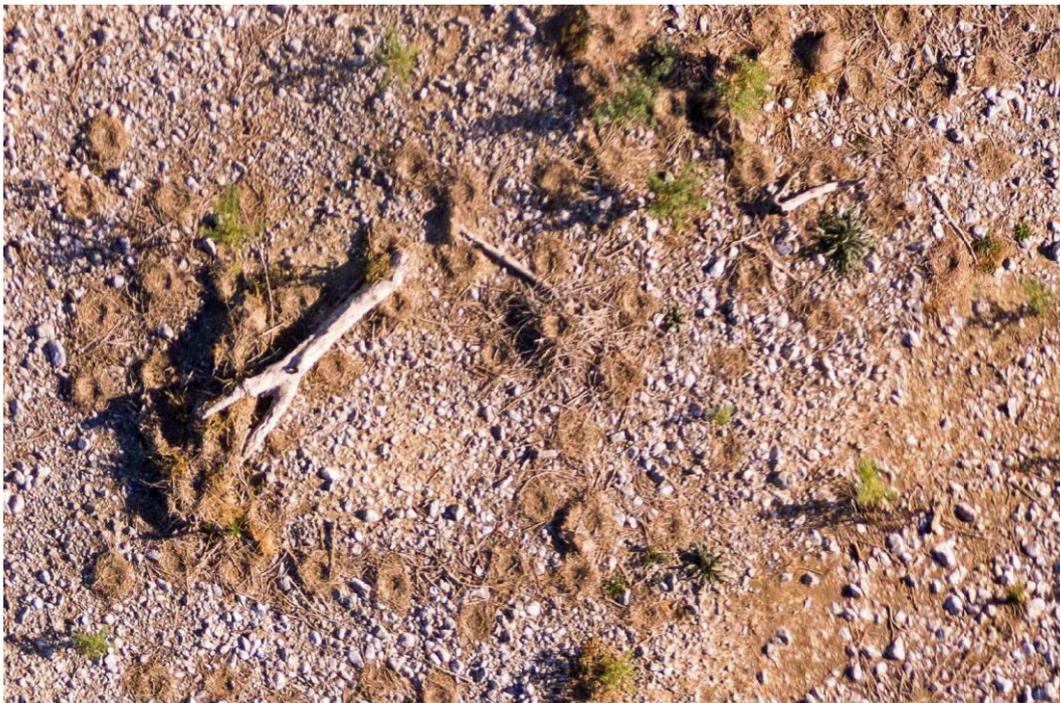
Figure 12 shows part of the Smarts 2018 – 2019 colony. The great majority of nests are also in poorly sorted coarse gravel, in spaces between the larger pebbles. But this image makes it clear that BBG are more weed tolerant than BFT – they sometimes nest close to large weed plants, sometimes under them, and often like to nest close to logs and driftwood. When optimal nesting habitat isn't available, e.g. 2016, they can even nest in worked paddocks – before they become vegetated. Figure 13 shows a distribution of maximum pebble size similar to that at Toppings, and to the BFT nests.

Figure 12. Part of Smarts 2018 - 2019 BBG colony area

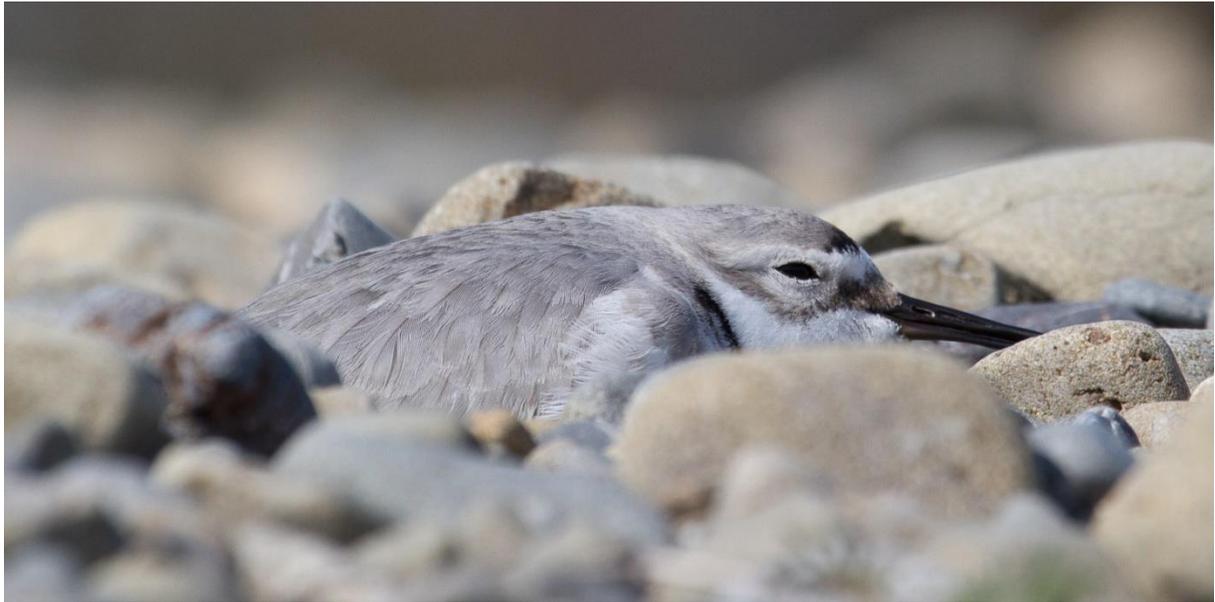
Figure 16. Wrybill on nest crouching beneath the level of large pebbles

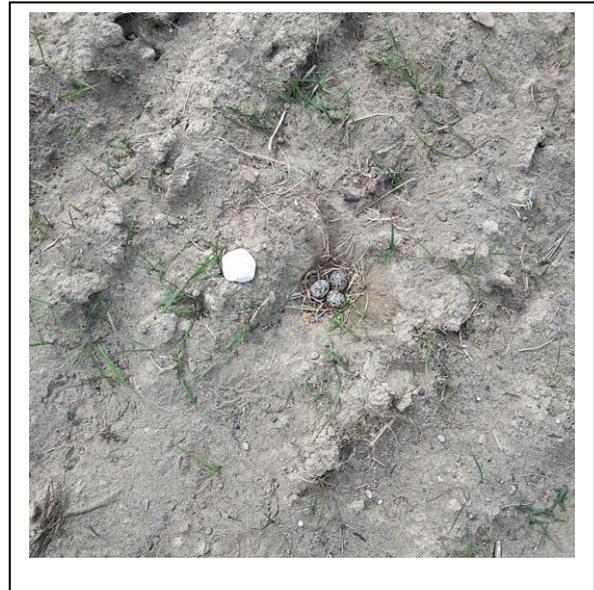
Figure 18. BD nest on sand

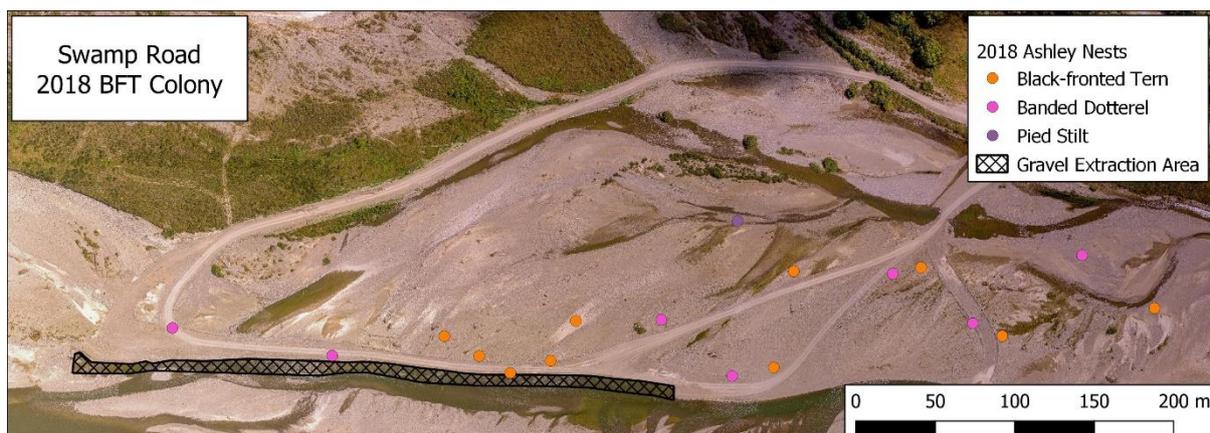
Figure 26. Swamp Road 2018 BFT colony

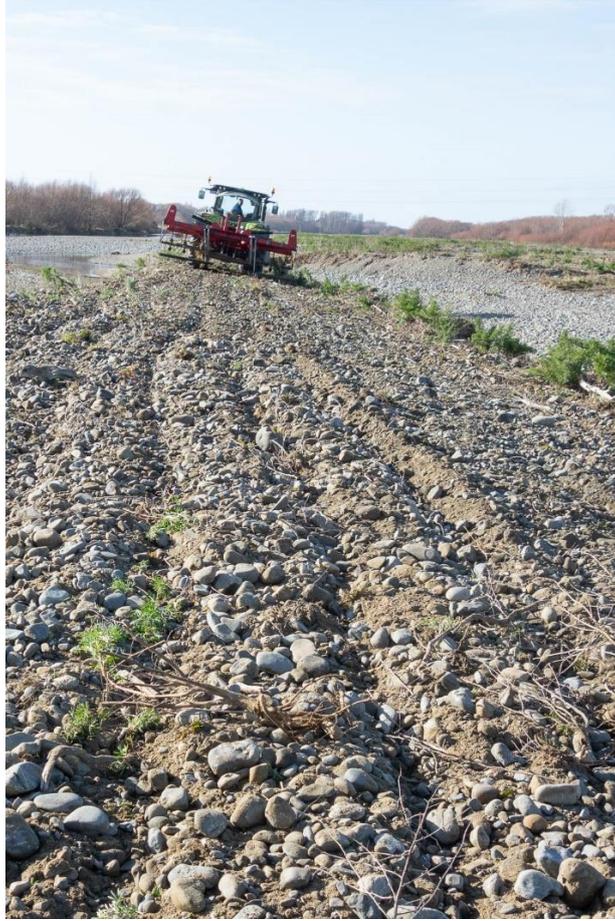
Figure 33. Tractor mounted ripper in action

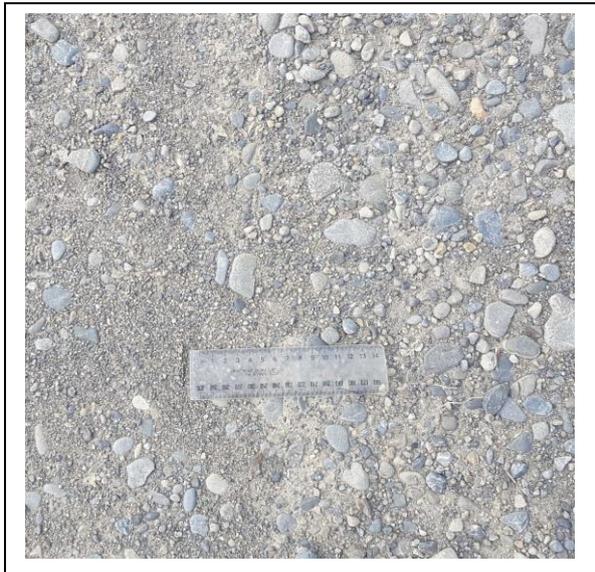
After the area had been graded field mapping showed less than 2% of the area consisted of uncompacted coarse poorly sorted gravel (Figure 38, Figure 37). Only a very small part of the area had that basic lithology, and compaction by the grader blade, the grader and truck etc. wheels led to the large pebbles being flattened down. Loosening the gravel by some sort of ripper would probably not be worth the expense as the basic lithology is not optimal for nesting. However, a trial of this will be done in the 2020 season.

Figure 37. Compacted fine sandy gravel

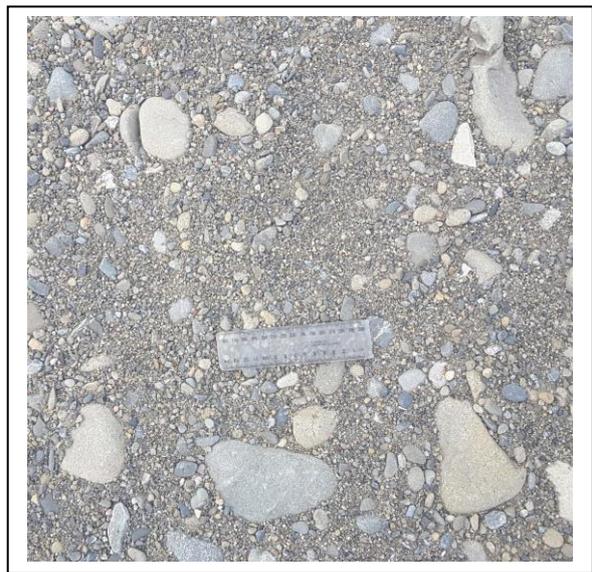
Figure 38. Compacted coarse poorly sorted sandy gravel

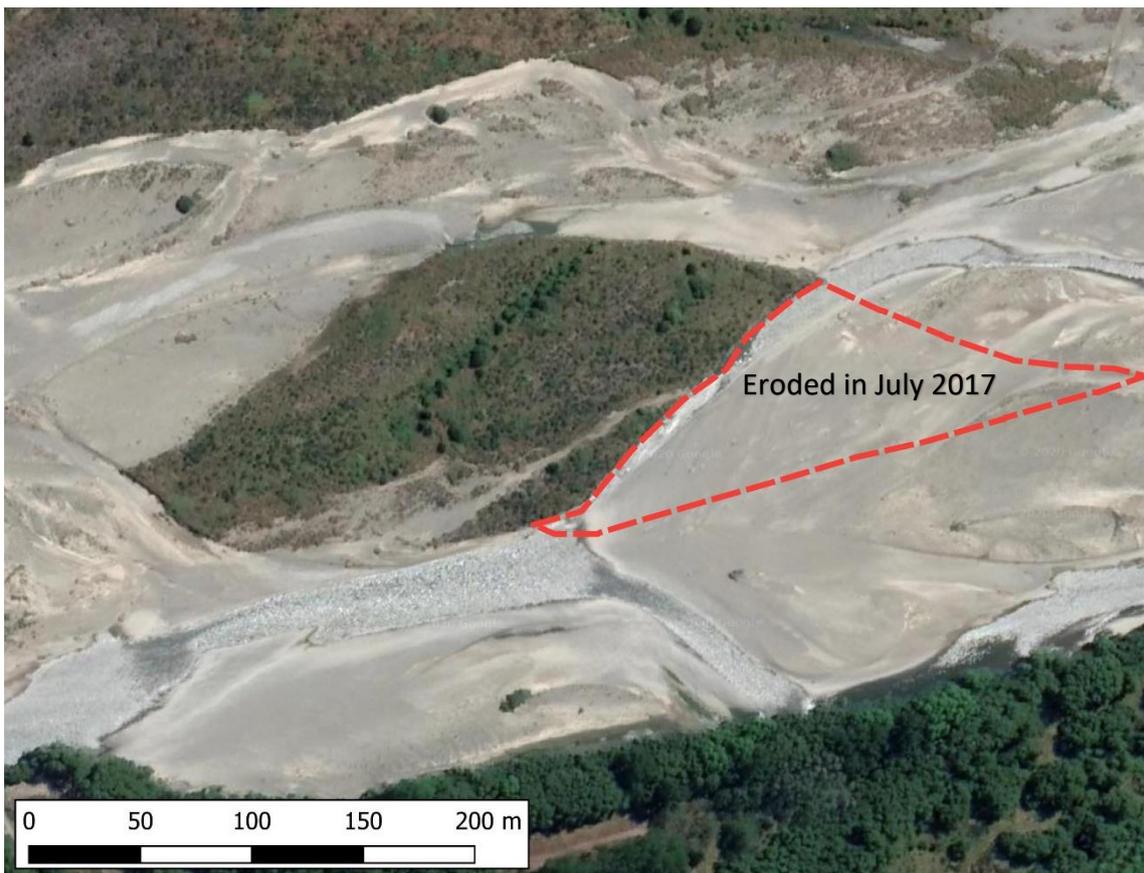
A similar process seems to be happening on the Ashley - except where vegetation prevents it (Figure 39). This process is necessary for the river to create nesting habitat by getting rid of sand and weeds and creating new gravel bars.

Figure 39. Heavily vegetated island, Google Earth 19/1/19

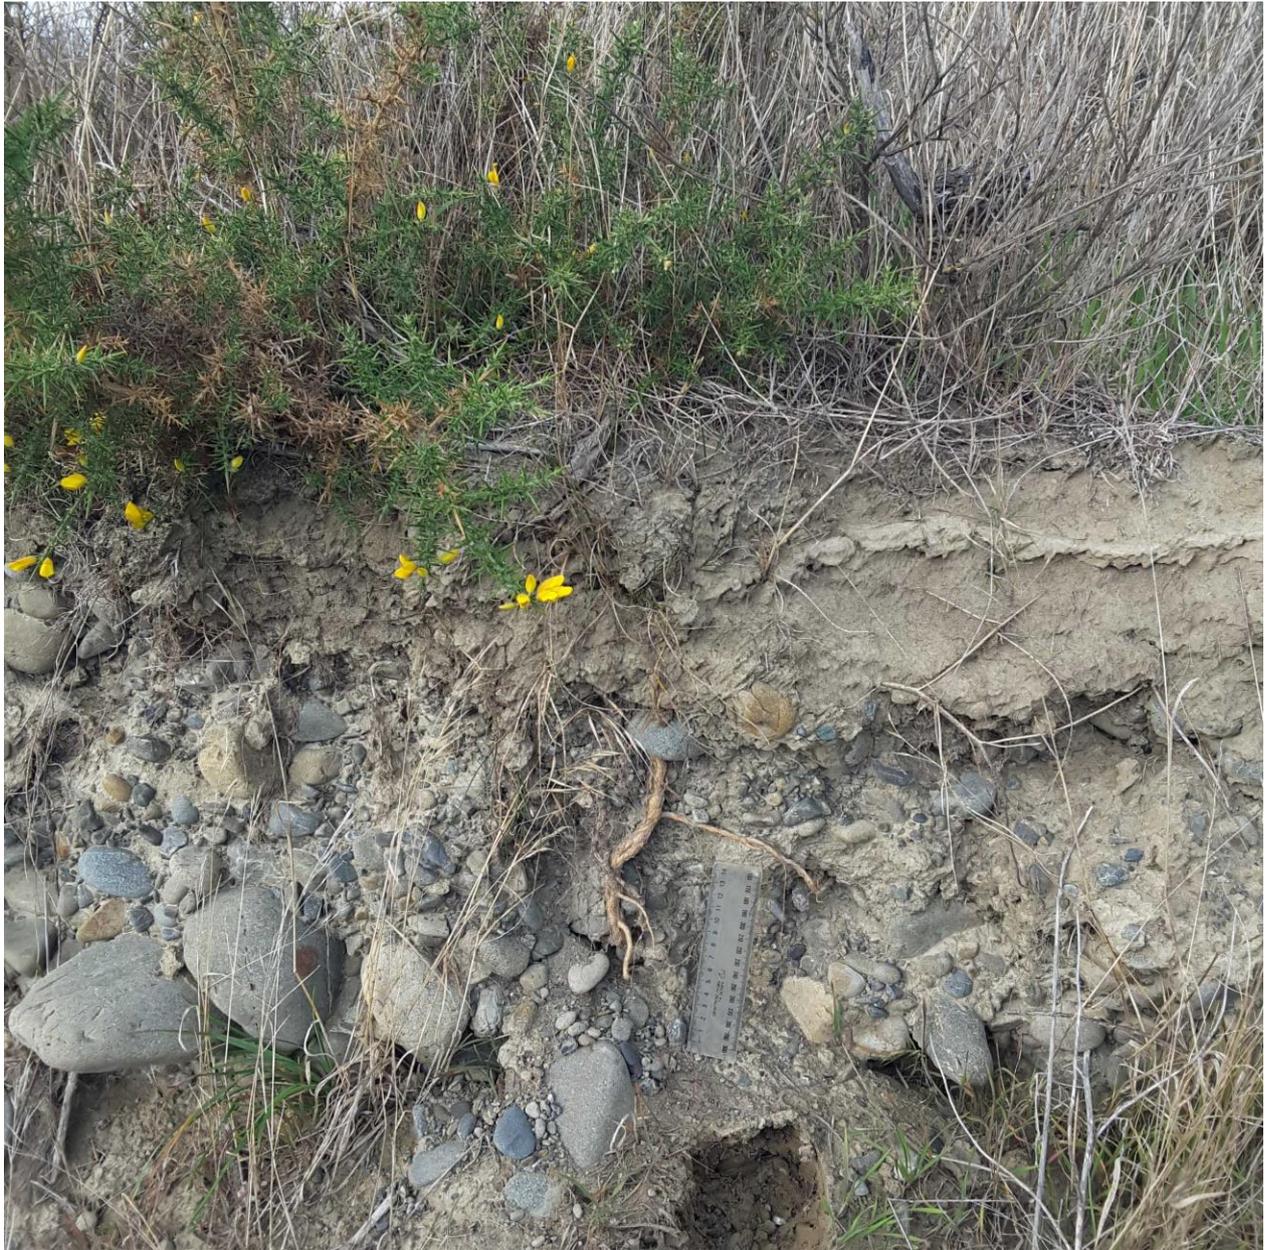
Figure 40. Island-top sand

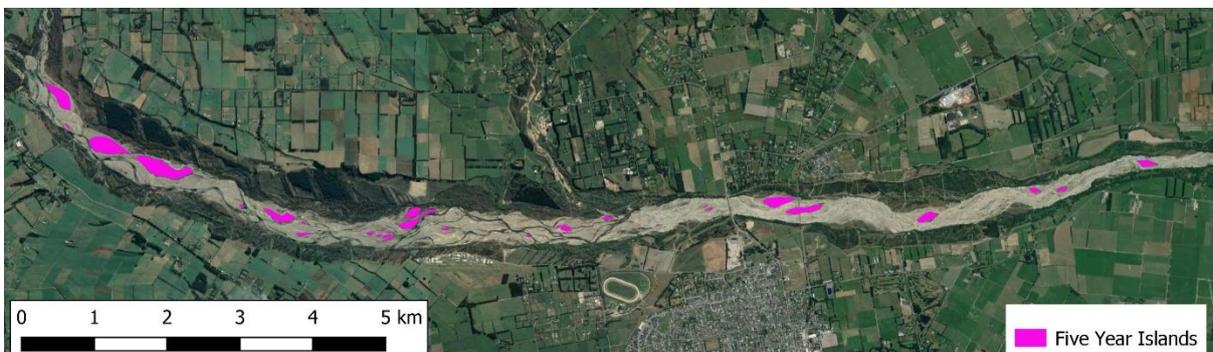
Figure 41. Islands that haven't been eroded in at least 5 years
