# **Weed removal by tractor-mounted undercutter on the Ashley-Rakahuri river**

Nick Ledgard (NL) and Grant Davey (GD), Ashley-Rakahuri Rivercare Group (ARRG)

## **Report to ECan. August, 2020**

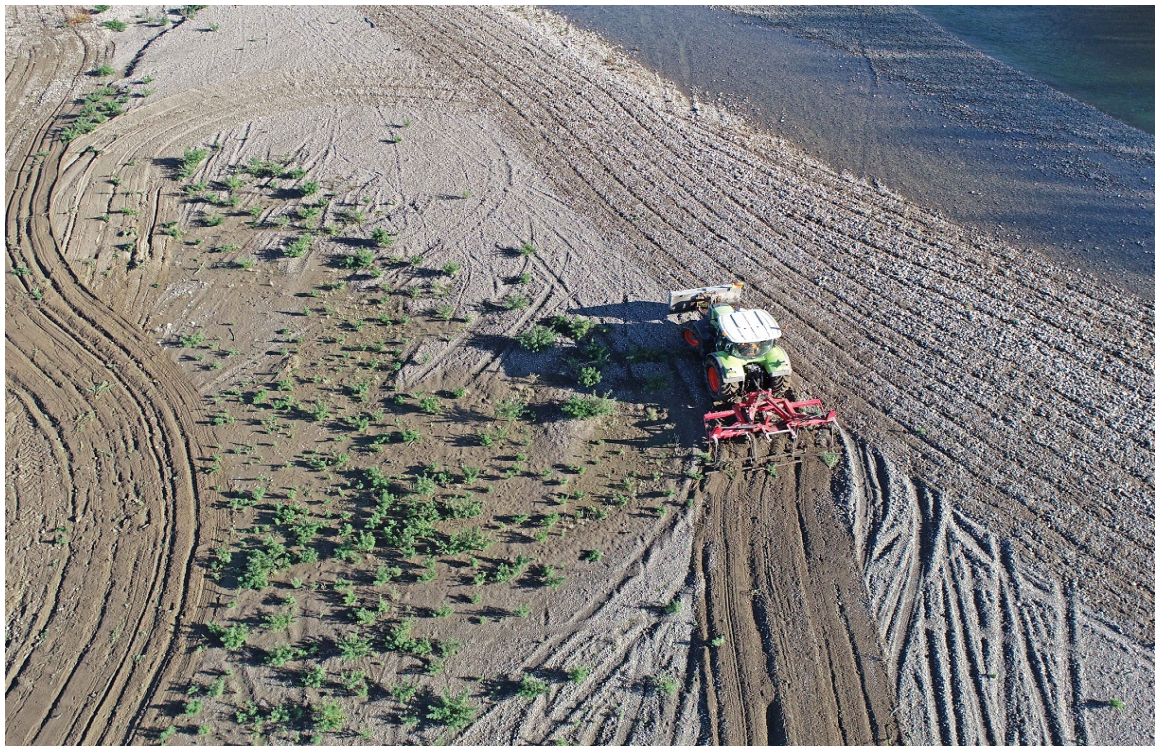
Clearing weeds at Toppings

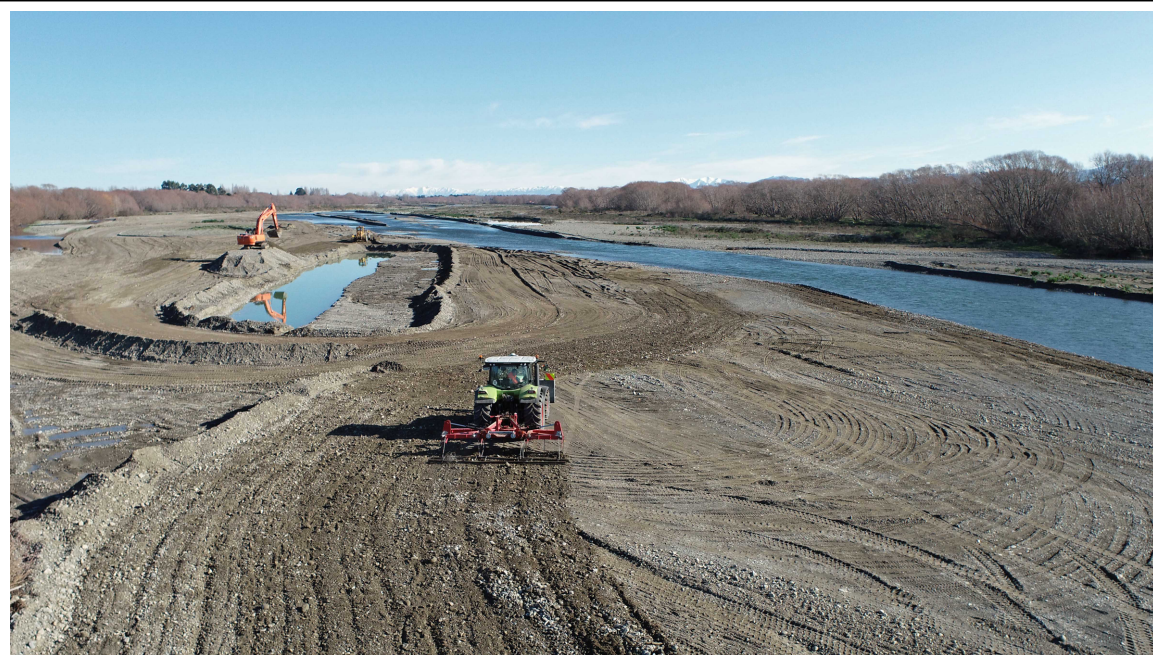
Loosening compacted surface at Smarts – Taggart gravel extraction area

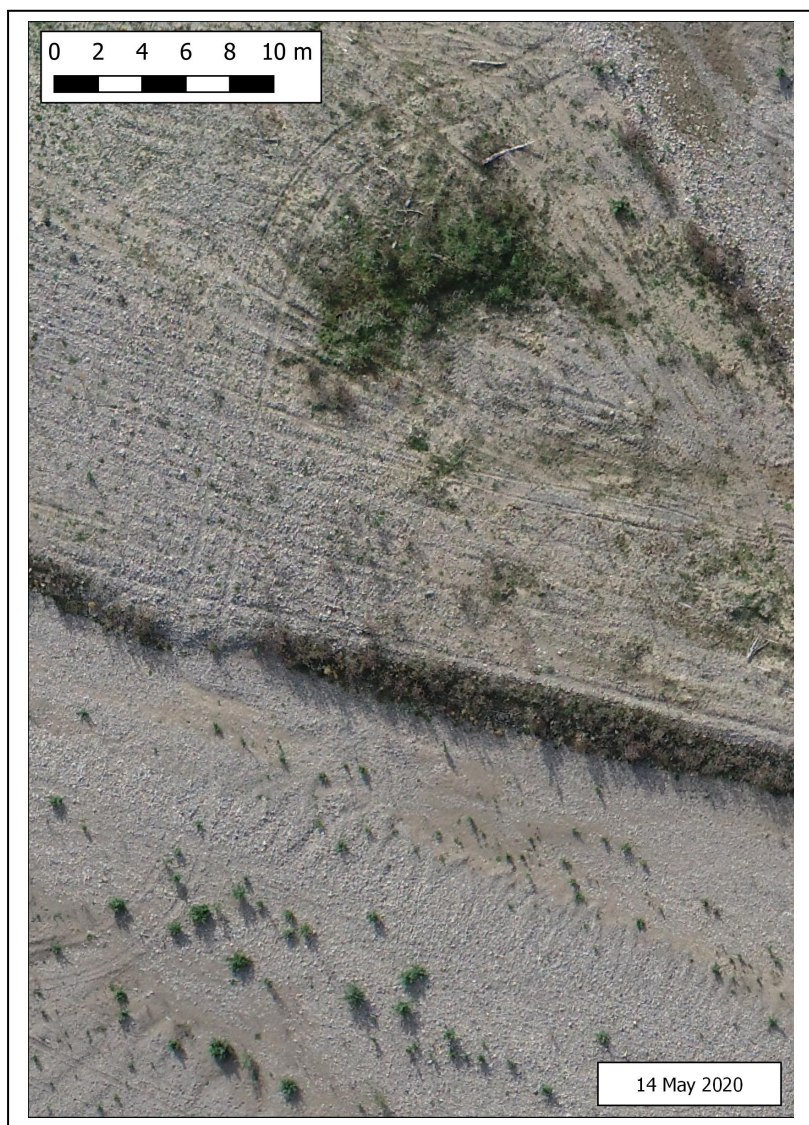
Part of Railway area prior to clearing

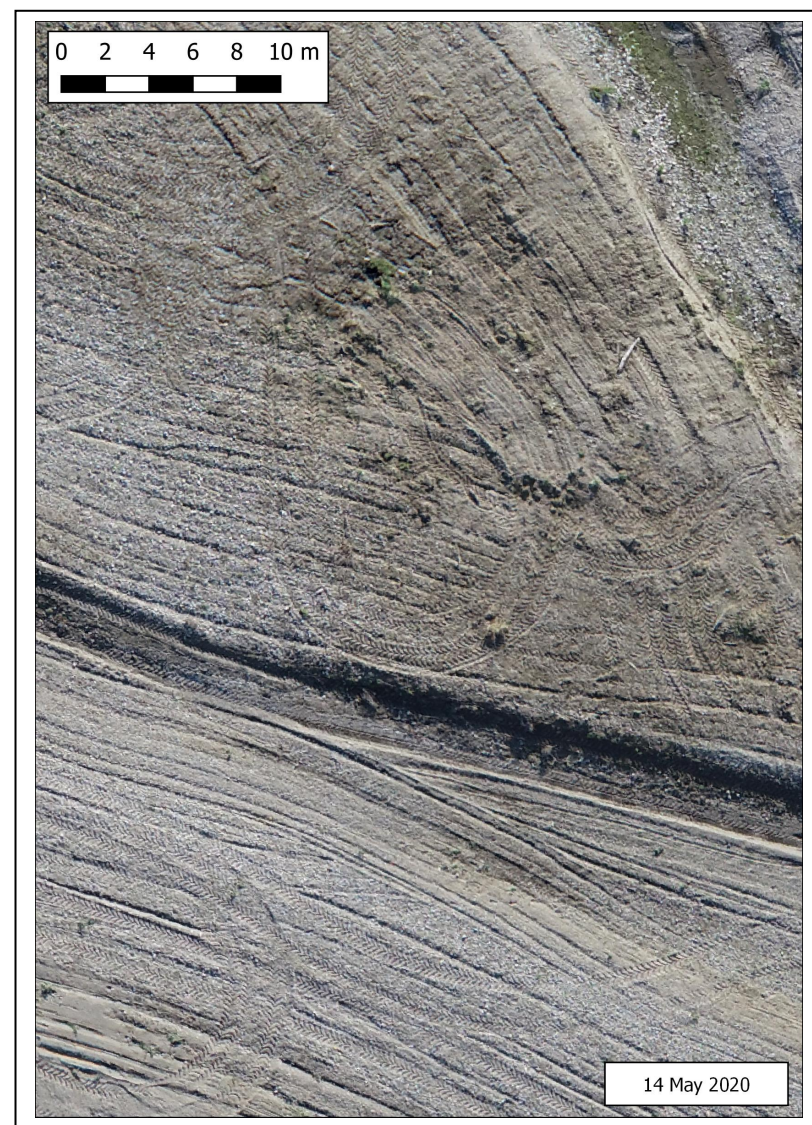
Same area after clearing
